MEMORANDUM

June 3, 2015

TO: Roscoe
FROM: Building and Zoning staff
SUBJECT: Sheriff's House and Jail Issues

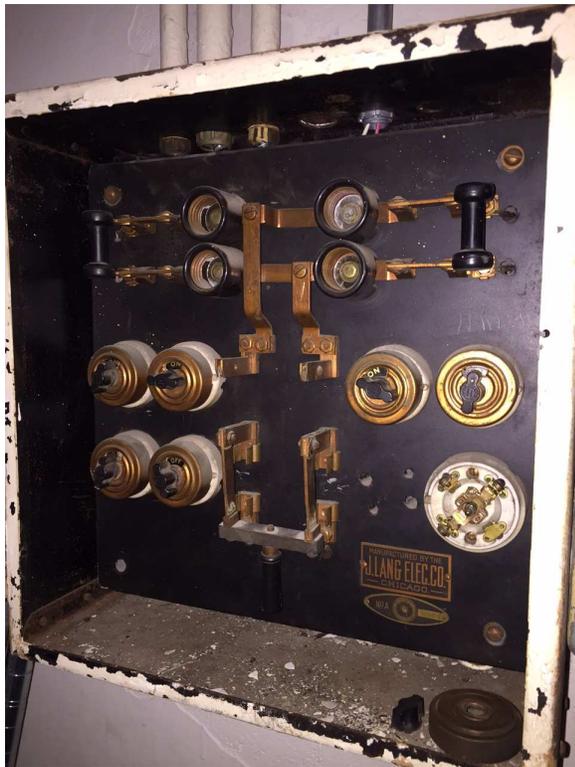
ELECTRICAL: The electrical system should be upgraded immediately, regardless of whether or not the restaurant is leased. The many open junction boxes reveal a host of concerns including ungrounded and uninsulated wiring, undersized circuits, old cloth wiring, creating the potential

for fire and electric shock. The circuit breaker box in the jail area on the second floor probably dates to 1912 when the jail underwent a major remodel. There are signs of corrosion throughout the building. Most of the light fixtures in the Sheriff's House have been removed.

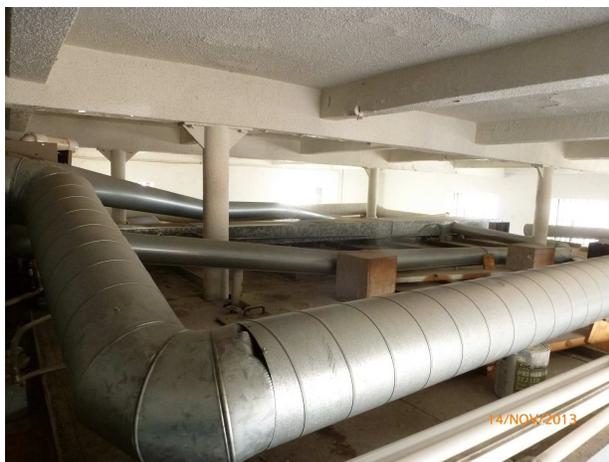
HVAC: Heating and cooling equipment are included in the City's annual maintenance contract. According to our file, there is a gas fired furnace in basement that heats the first floor of the restaurant (furnace is 14 years old), a furnace in the attic which heats the second floor (9 years old), and a gas fired furnace above the jail cells that heats the first floor of the jail (age unknown). There second floor of the jail is unheated. Ventilation throughout the building needs to be evaluated and improved and ductwork needs to be cleaned.

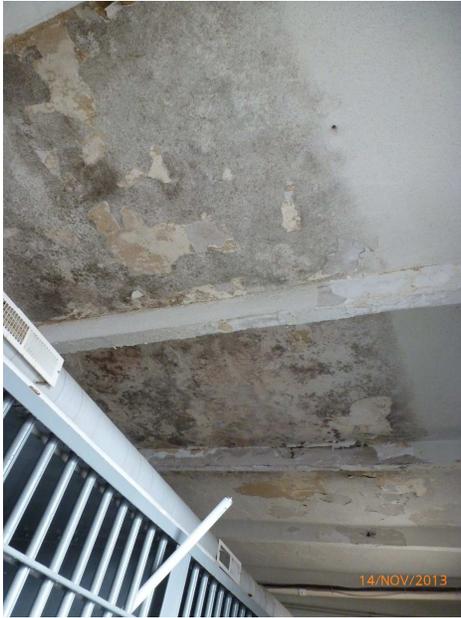
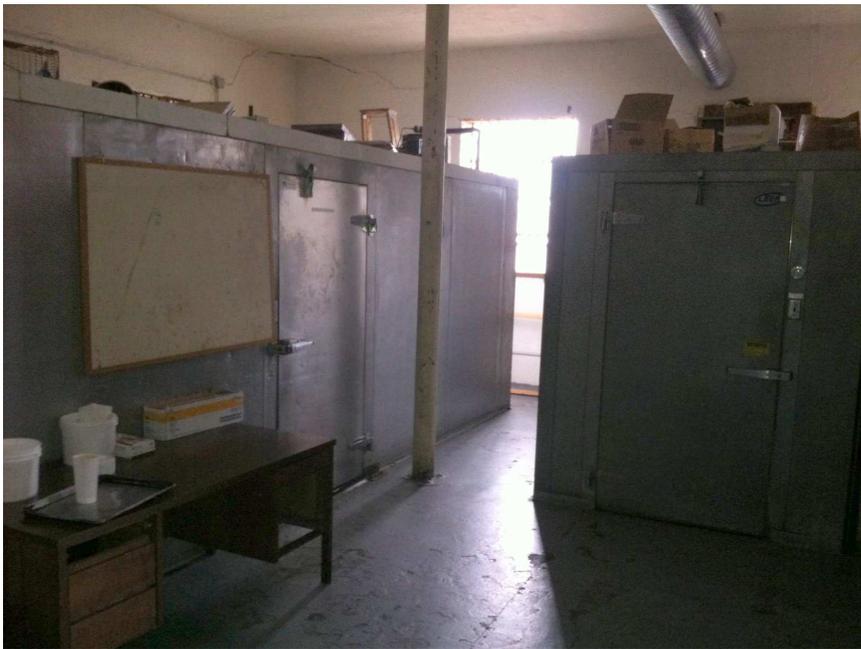
MOLD AND COOLERS: Mold was observed in various locations. Mold growth has been a recurring problem on the first floor ceiling of the jail below the second floor coolers, but there are other areas where inadequate ventilation is leading to mold and corrosion. The mold in the photo below forms under the improperly vented second floor coolers. The ceiling will need to be re-plastered.

Kathy Cappas said that the existing coolers will be removed however, if they are not removed, they must not be used as presently installed. Gary Anderson included cooler ventilation as an immediate priority. Because an improperly designed system has the potential to create significant damage to the building, any future cooler ventilation must be professionally designed and reviewed.

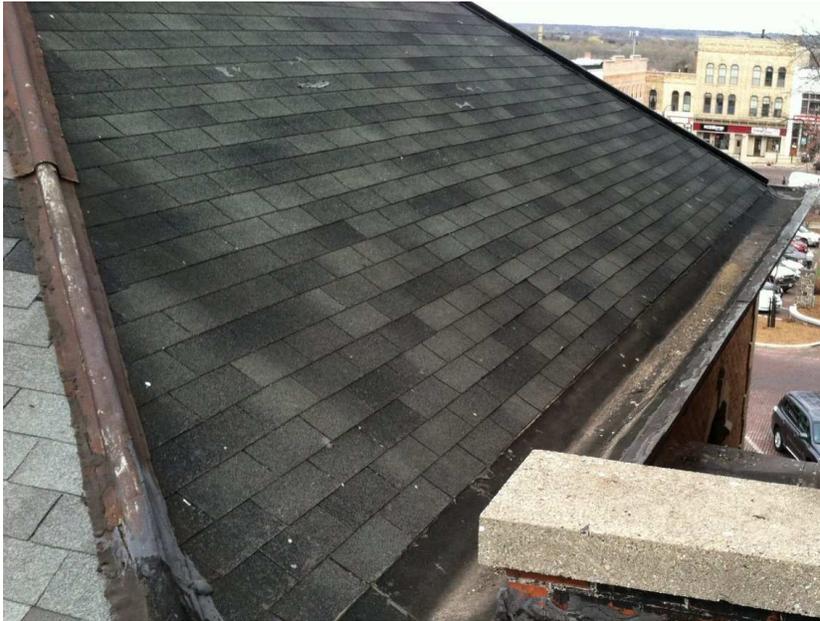
ROOF: Former CED staff members spoke with Kathy Cappas about a roof leak problem which is probably attributed to way the roof from the courthouse passageway meets the jail roof. We are unsure if last year's roofing project corrected or if it still needs to be repaired. The front roof (Sheriff's House) is old and has leaked into the upstairs dining room It was patched in 1912 but will need to be replaced . We are not aware of any current leaks from this roof.

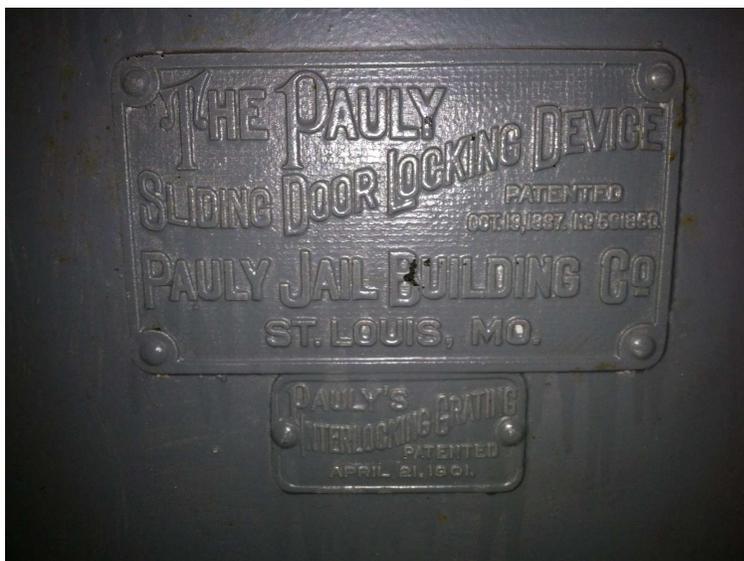
There are many unique metal mechanical features unique to the jail environment—many which remain in place, others removed and set off to the side. Some of these items such as the dismantled jail cells have considerable value. These items should be inventoried and maintained. Any future tenant must recognize the historic importance of these components to the building.

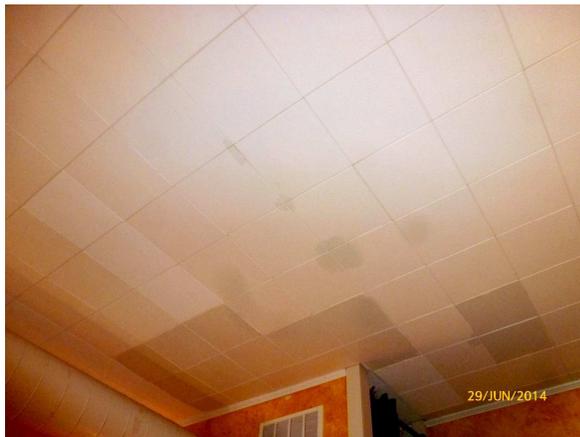
Some of the acoustical ceilings in the second floor dining room are discolored or different colors. A full restoration of this space would include the removal of the tile and restoration of the plaster ceiling.

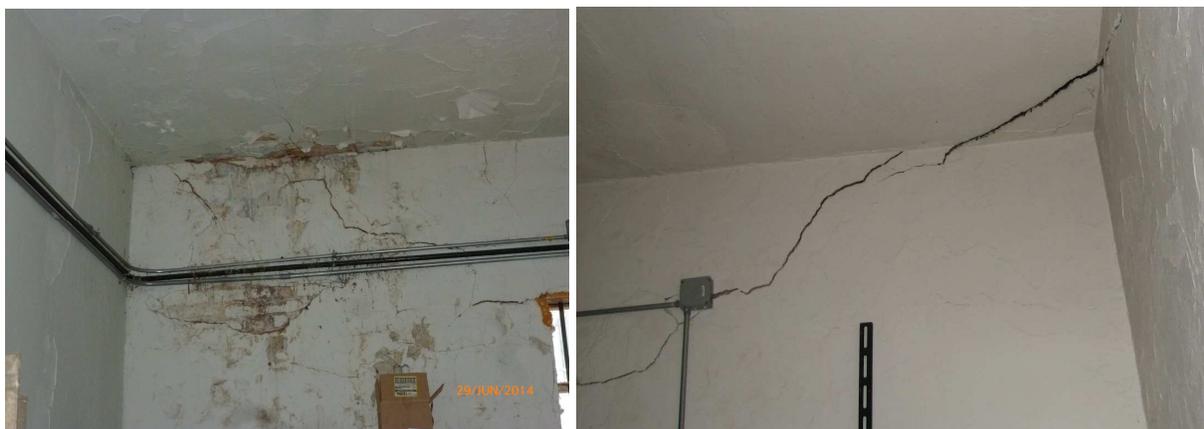
The plaster on the walls and ceilings in the jail should be removed. Gary Anderson identified plaster removal as a high priority item in his initial report because pieces have started to pull away for the ceiling of the jail. The exposed brick may create an attractive restaurant ambiance, however, it could impact the future use of historic tax credits.

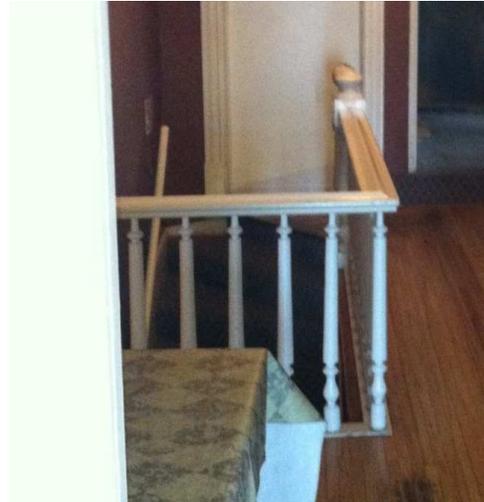
RAILINGS: The stairway railings in the Sheriff’s House do not meet minimum code height nor does the railing at the top of the stairs. Since the plaster needs to be patched, the stairway railing should be removed and reattached at the proper height as part of that process.

The balustrade on the second floor should be retained but an additional (taller) code compliant railing should be added.

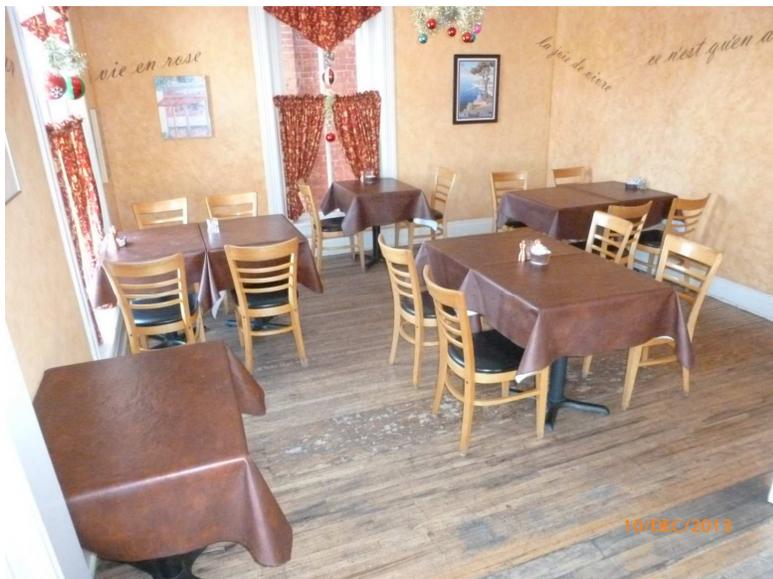
FLOORING: The restaurant dining rooms have wood flooring which has been patched. There are some areas that need additional patching. The floor should be reconditioned or sanded and refinished if necessary. The flooring behind the bar is rotted and will need to be removed and replaced or recovered. Other flooring needs some patching and refinishing, particularly in the front dining room on the second floor.

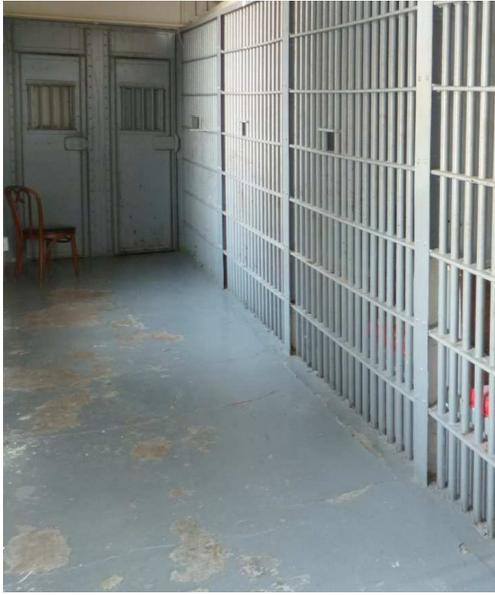
Concrete floors in the jail need to be cleaned, scraped and repainted.

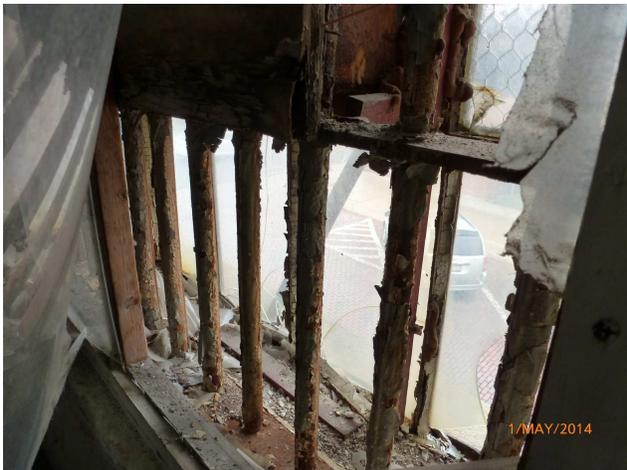
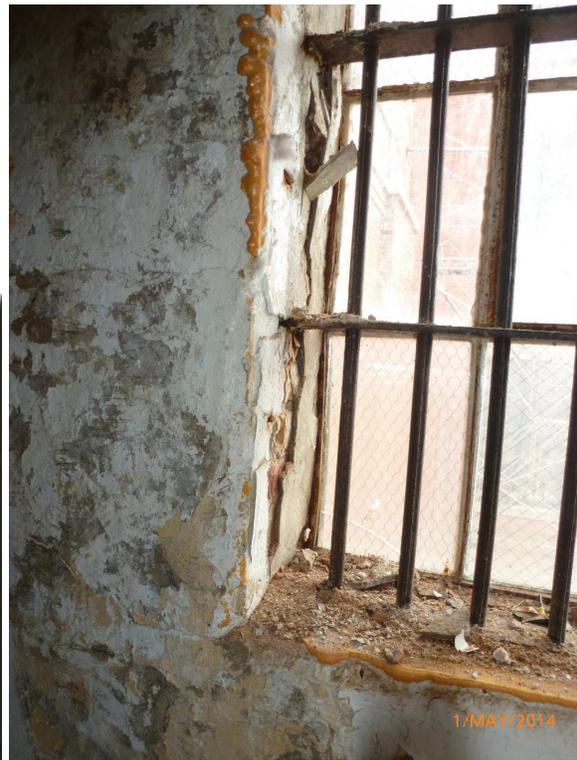
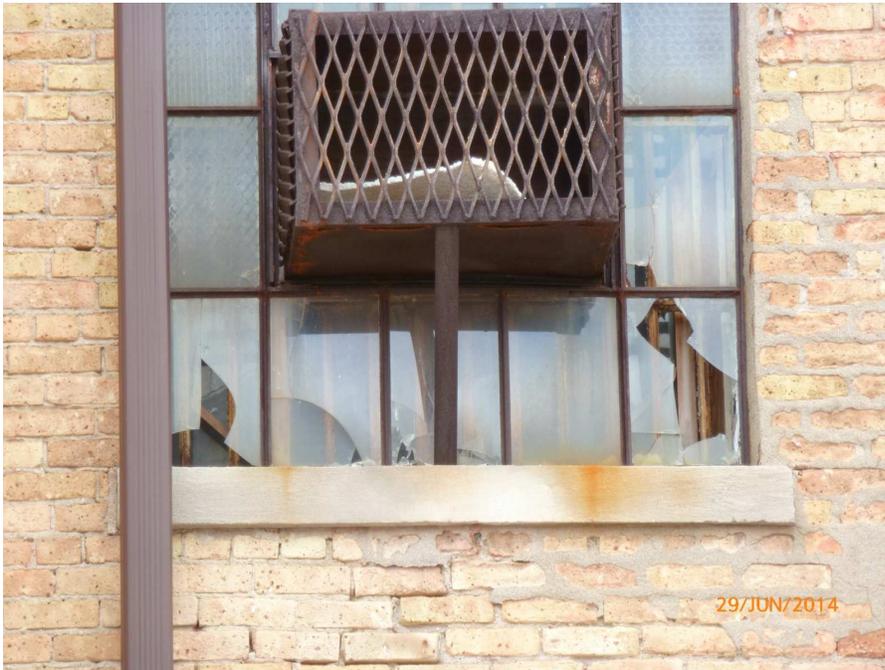
WINDOWS: There are urgent window issues throughout the building. The upper pane of glass in one of the sash above the front entrance has slipped leaving a gap of an inch or more between the glass and the sash due to rotted meeting rail on the upper sash. Other double hung windows are approaching this conditions also.

The multi-paned steel windows in the jail have a multitude of restoration needs. The photo below illustrates rust, peeling paint, and broken glass all surrounded by cracked plaster and peeling paint.

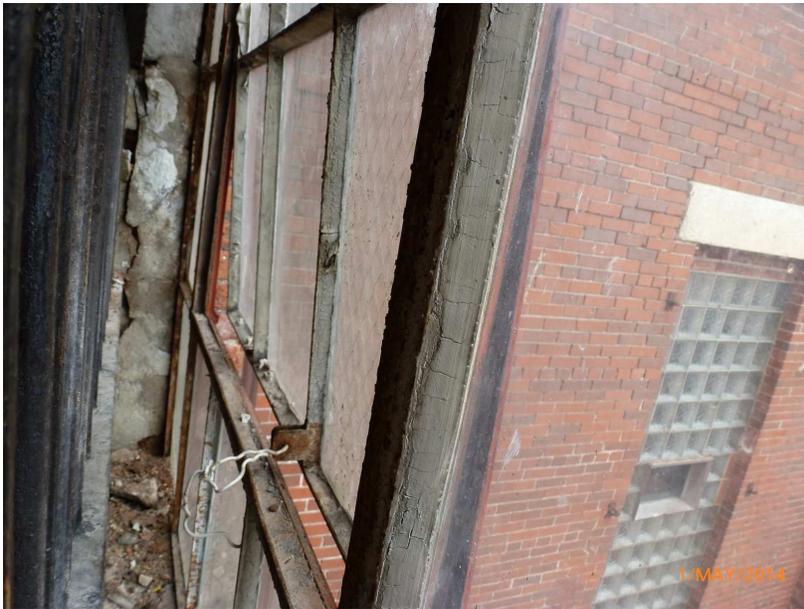
The bars add further complexity to the repair of deteriorated jail windows as illustrated in the photo below.

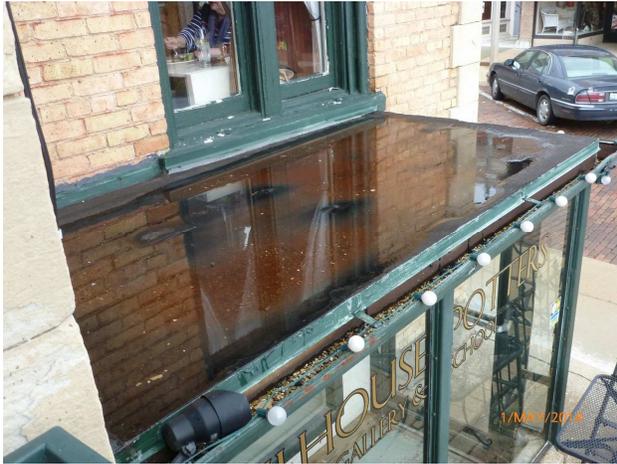
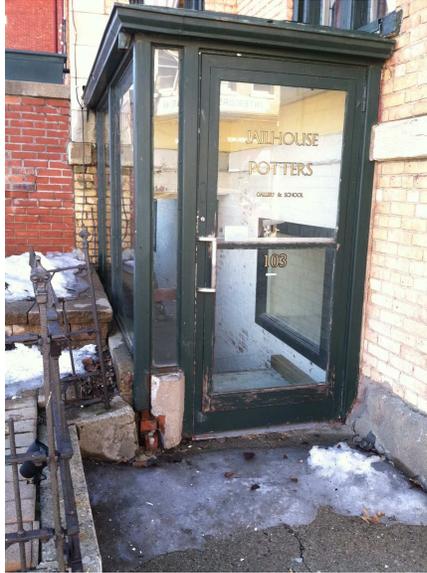
There are major problems with both the front and rear entrance enclosures. Since neither are original there may be other designs that are more desirable or aesthetically pleasing.

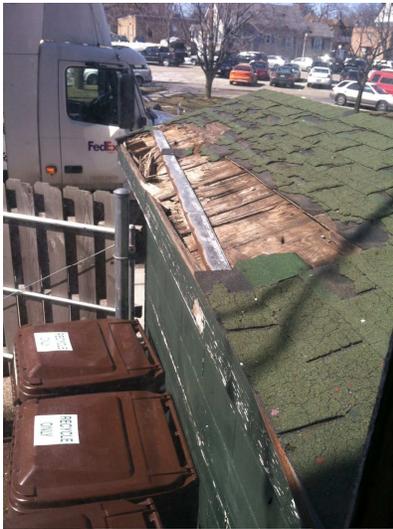
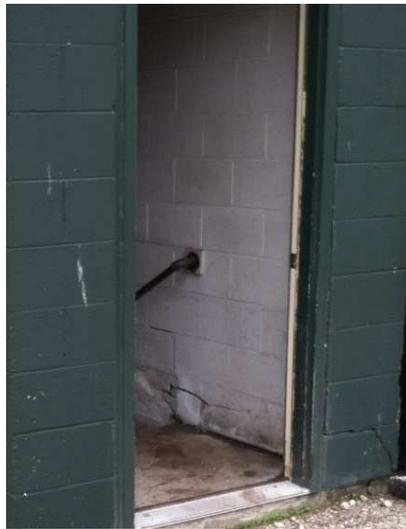
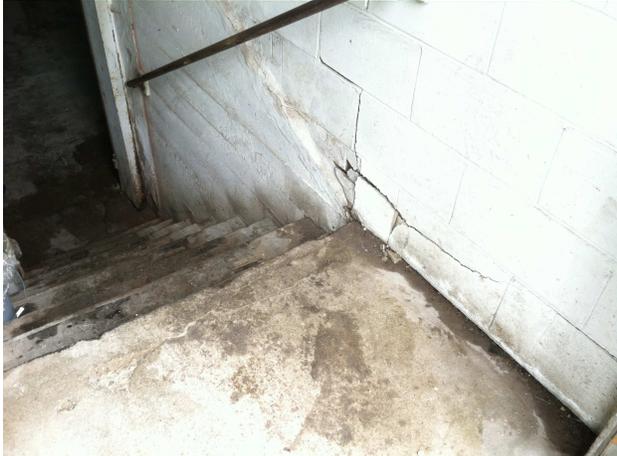
The back entrance needs major repairs. The roof is rotted and the concrete block is cracked and shifted.
